Annual Inspection Report - 2024

For Compliance with the EPA Coal
Combustion Residuals (CCR) Rule
40 CFR §257.83(b)

Erickson Power Station –
Forebay, Retention Basin, and
Clear Water Pond

February 21, 2024

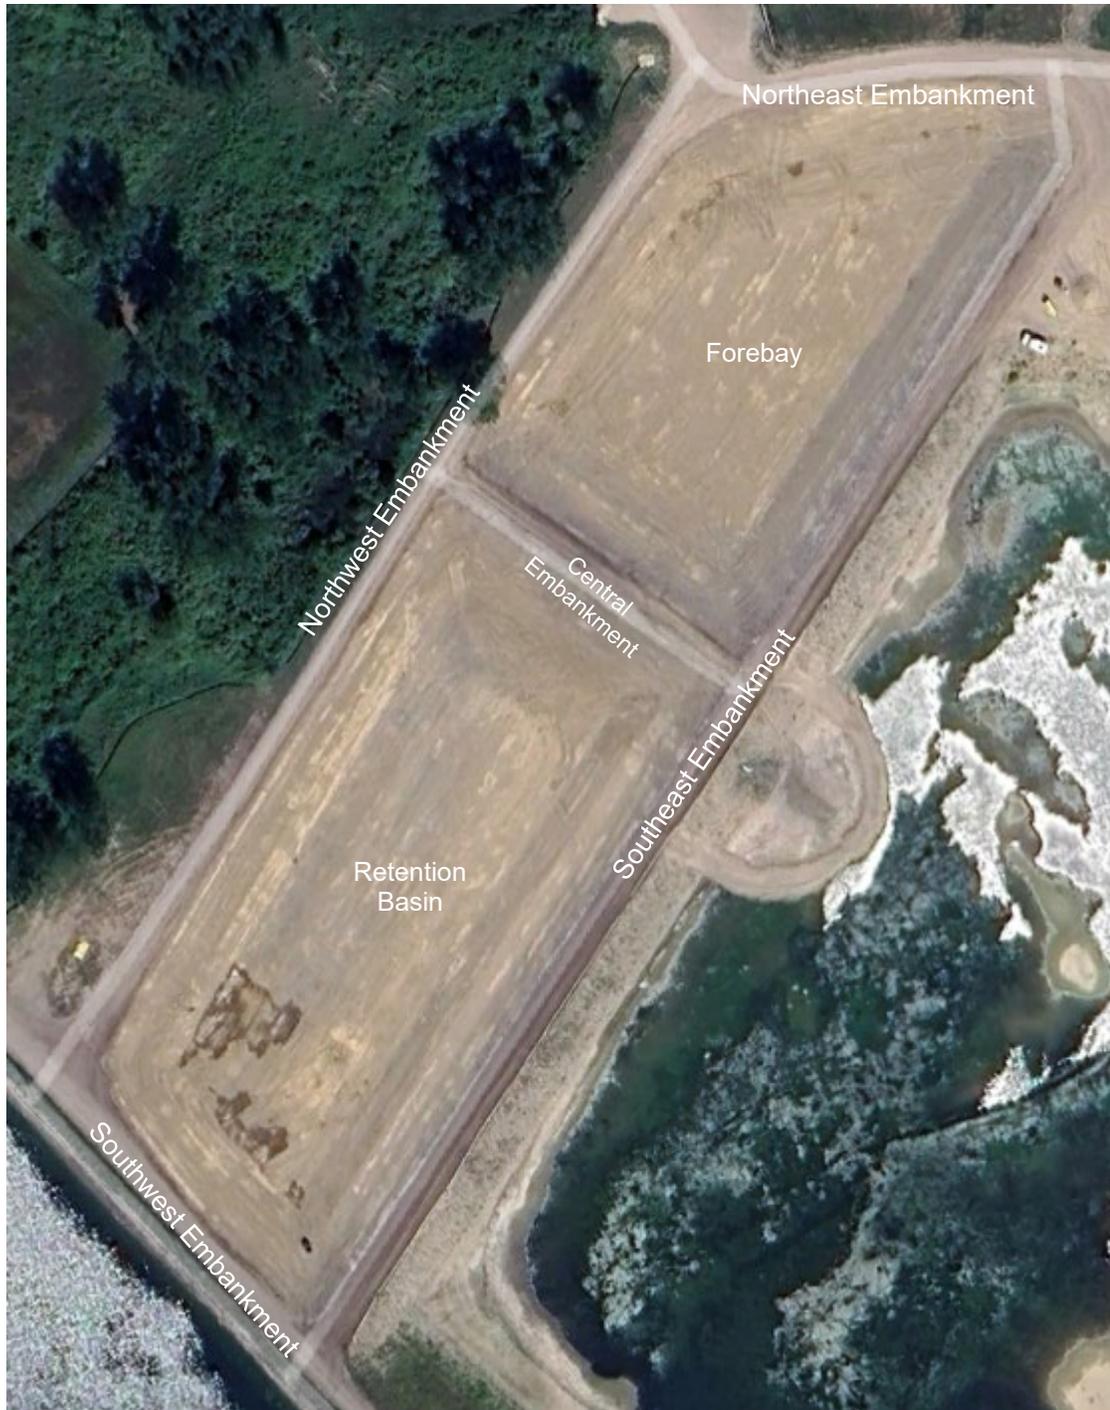
Figure 3. Forebay and Retention Basin Embankment Terminology

The Southeast Embankment separates the Forebay and Retention Basin to the northwest and the Former Impoundment, which is closed, to the southeast. The Southeast Embankment appeared to be in good condition and no evidence of movement, settlement, cracking, distress, seepage, animal burrows or other adverse conditions was observed in the crest and upstream and downstream slopes.

- The crest of the embankment consisted of a gravelly/soil surface which was in good condition.
- The rip-rap protecting the interior slope has been removed. The rip-rap on the exterior slope appears to be in good condition.
- No vegetation is currently present.
- Erosion is present on the interior embankment where construction has occurred and no vegetation is present. This condition is temporary and this embankment will be removed after CCR removal verification of the impoundment is complete.

The Northeast Embankment separates the Forebay to the southwest and the Hydro-Bins and grassy areas to the north. The Northeast Embankment appeared to be in good condition, and no evidence of movement, settlement, cracking, distress, seepage, animal burrows or other adverse conditions was observed.

- The crest of the embankment consisted of a gravelly/soil surface which was in good condition.
- The rip-rap protecting the interior slope has been removed.
- No vegetation is currently present.
- Erosion is present on the interior embankment where construction has occurred and no vegetation is present. This condition is temporary and this embankment will be repaired and reseeded after CCR removal verification of the impoundment is complete.

The Northwest Embankment separates the Forebay and Retention Basin to the southeast and wooded areas to the northwest. The Northwest Embankment appeared to be in good condition, and no evidence of movement, settlement, cracking, distress, seepage, animal burrows or other adverse conditions was observed in the crest and upstream and downstream slopes.

The Southwest Embankment separates the Retention Basin to the northeast and Lake Delta to the southwest. The Southwest Embankment appeared to be in good condition, and no evidence of movement, settlement, cracking, distress, seepage, animal burrows or other adverse conditions was observed in the crest and upstream and downstream slopes.

- The rip-rap protecting the interior slope has been removed and vegetation covers the exterior slope (adjacent to Lake Delta). The crest of the embankment consisted of a gravelly/soil surface. The crest and slopes appeared to be in good condition.
- No vegetation is currently present.
- Erosion is present on the interior embankment where construction has occurred and no vegetation is present. This condition is temporary and this embankment will be repaired and reseeded after CCR removal verification of the impoundment is complete.

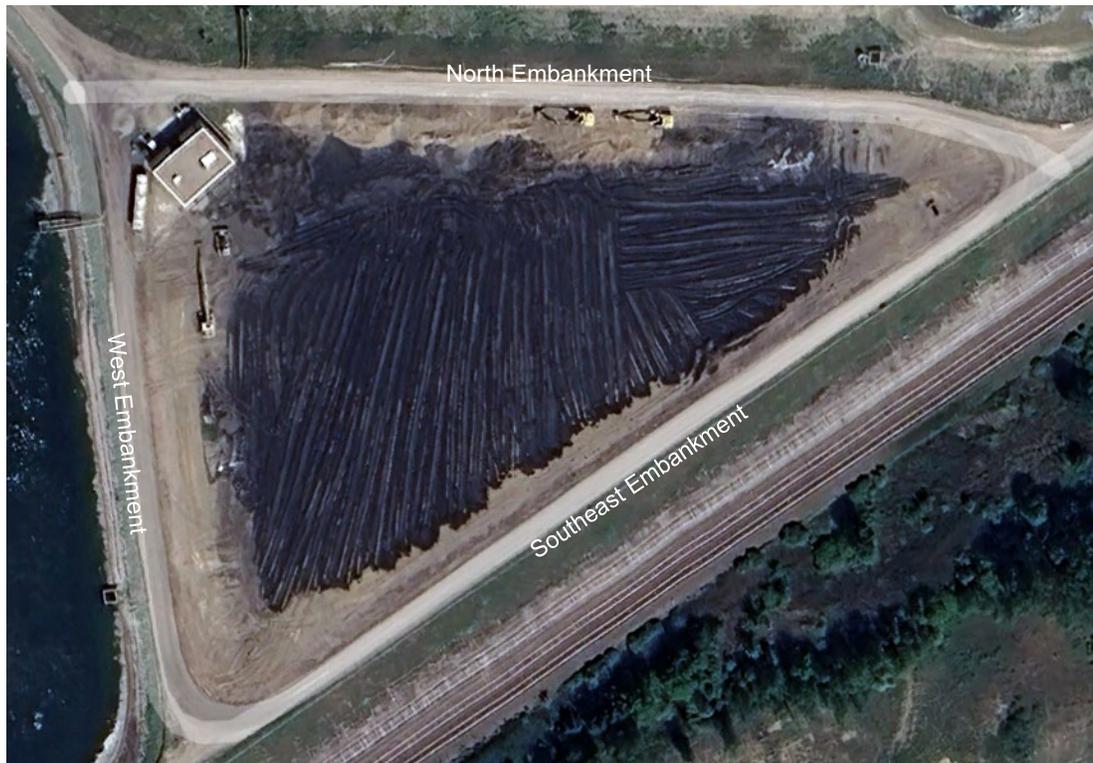
Figure 5. Clear Water Pond Embankment Terminology

The Southeast Embankment separates the Clear Water Pond to the northwest and the swale and railroad to the southeast. The Southeast Embankment appeared to be in good condition and no evidence of movement, settlement, cracking, distress, seepage, animal burrows or other adverse conditions was observed in the crest and upstream and downstream slopes.

- This embankment has been temporarily restricted of vehicle traffic due to the ongoing construction efforts as a portion of the interior crest has been removed.
- The crest of the embankment consisted of a gravelly/soil surface. Minor rutting of the crest was observed.
- Riprap protecting the interior slope has been removed.
- Vegetation has been removed from the interior slope and the vegetation appears to have been maintained properly on the exterior slope of the embankment and at the exterior toe in the swale.
- Erosion is present on the interior embankment where construction has occurred and no vegetation is present. This condition is temporary and this embankment

will be repaired and reseeded after CCR removal verification of the impoundment is complete.

The North Embankment separates the Clear Water Pond to the south and the Former Impoundment, which is closed, to the north. The North Embankment appeared to be in good condition and no evidence of movement, settlement, cracking, distress, seepage, animal burrows or other adverse conditions was observed in the crest and upstream and downstream slopes.

- Vegetation has been removed from the interior slope and the vegetation appears to have been maintained properly on the exterior slope.
- The sloughing on the interior slope of the North Embankment, which was observed in previous inspections, is no longer present due to construction.

- The crest of the embankment consisted of a gravelly/soil surface. No evidence of movement, settlement, cracking, or other distress was observed in the crest other than minor rutting.

- Erosion is present on the interior embankment where construction has occurred and no vegetation is present. This condition is temporary and this embankment will be removed after CCR removal verification of the impoundment is complete.

The West Embankment separates the Clear Water Pond to the east and Lake Delta to the west. The West Embankment appeared to be in good condition and no evidence of movement, settlement, cracking, distress, seepage, animal burrows or other adverse conditions was observed in the crest and upstream and downstream slopes.

- Vegetation has been removed from the interior slope and the vegetation appears to have been maintained properly on the exterior slope.
- The crest of the embankment consisted of a gravelly/soil. No evidence of movement, settlement, cracking, or other distress was observed in the crest.
- Erosion is present on the interior embankment where construction has occurred and no vegetation is present. This condition is temporary and this embankment will be repaired and reseeded after CCR removal verification of the impoundment is complete.
