Structural Stability and Safety Factor Assessment

For Compliance with the EPA Coal
Combustion Residuals (CCR) Rule
40 CFR §257.73(d)
40 CFR §257.73(e)

Former Erickson Power Station –
Former Forebay, Former Retention Basin, and
Former Clear Water Pond

August 12, 2025

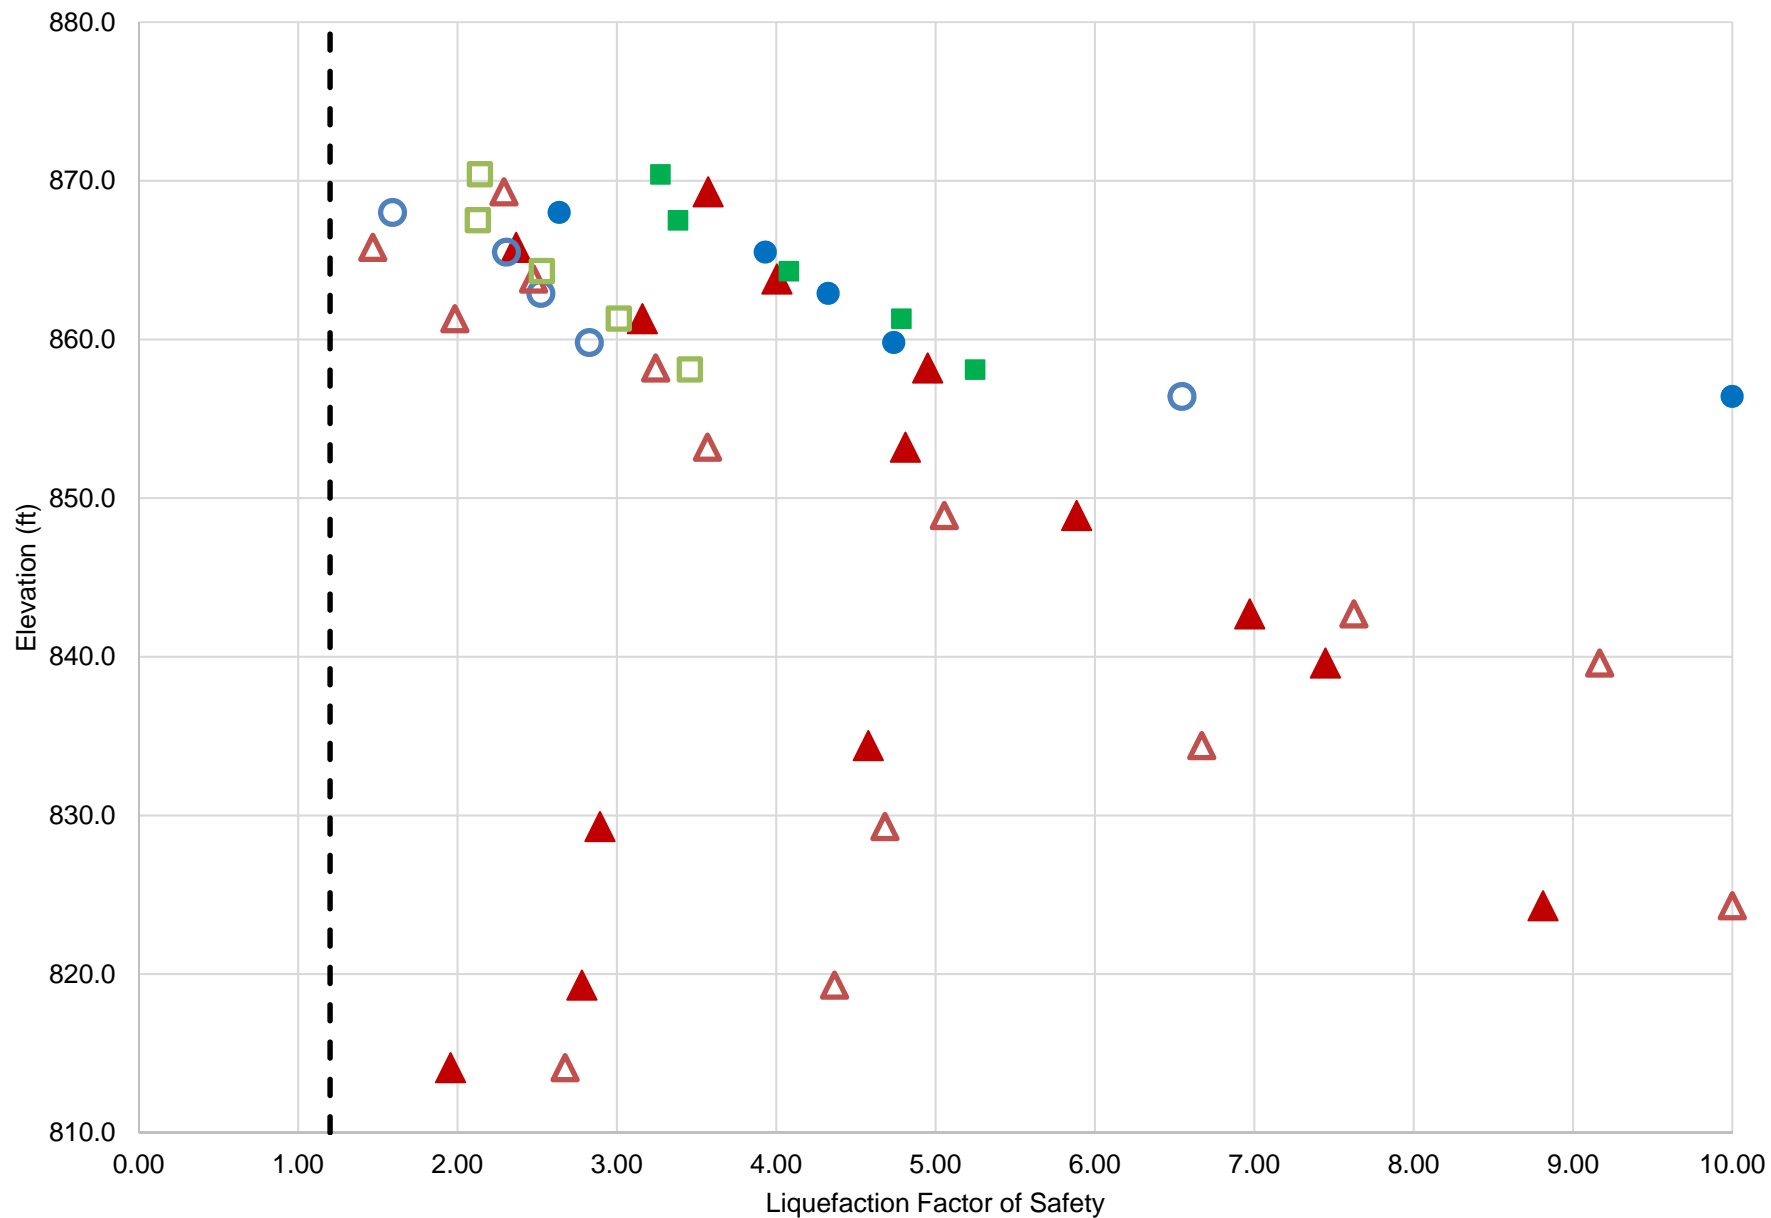
The static shear strength in the liquefaction-susceptible material is small. Therefore, K_α was taken equal to one for the purpose of this analysis. If the FS is greater than 1.2, soil is not susceptible to liquefaction. The calculated factor of safety against seismically-induced liquefaction is presented in on Page 3 of Attachment 2 and was calculated to be greater than 1.20 throughout the foundation depth. Considering that the embankment is classified as CL (USCS standard) and compacted material, the screening-level results indicate that the embankment and foundation soils are not susceptible to seismically-induced liquefaction for the seismic loading considered. In summary, the foundation was determined to be stable with respect to liquefaction for earthquakes up to the considered 2475-year return interval, which would have a PGA of 0.076g.

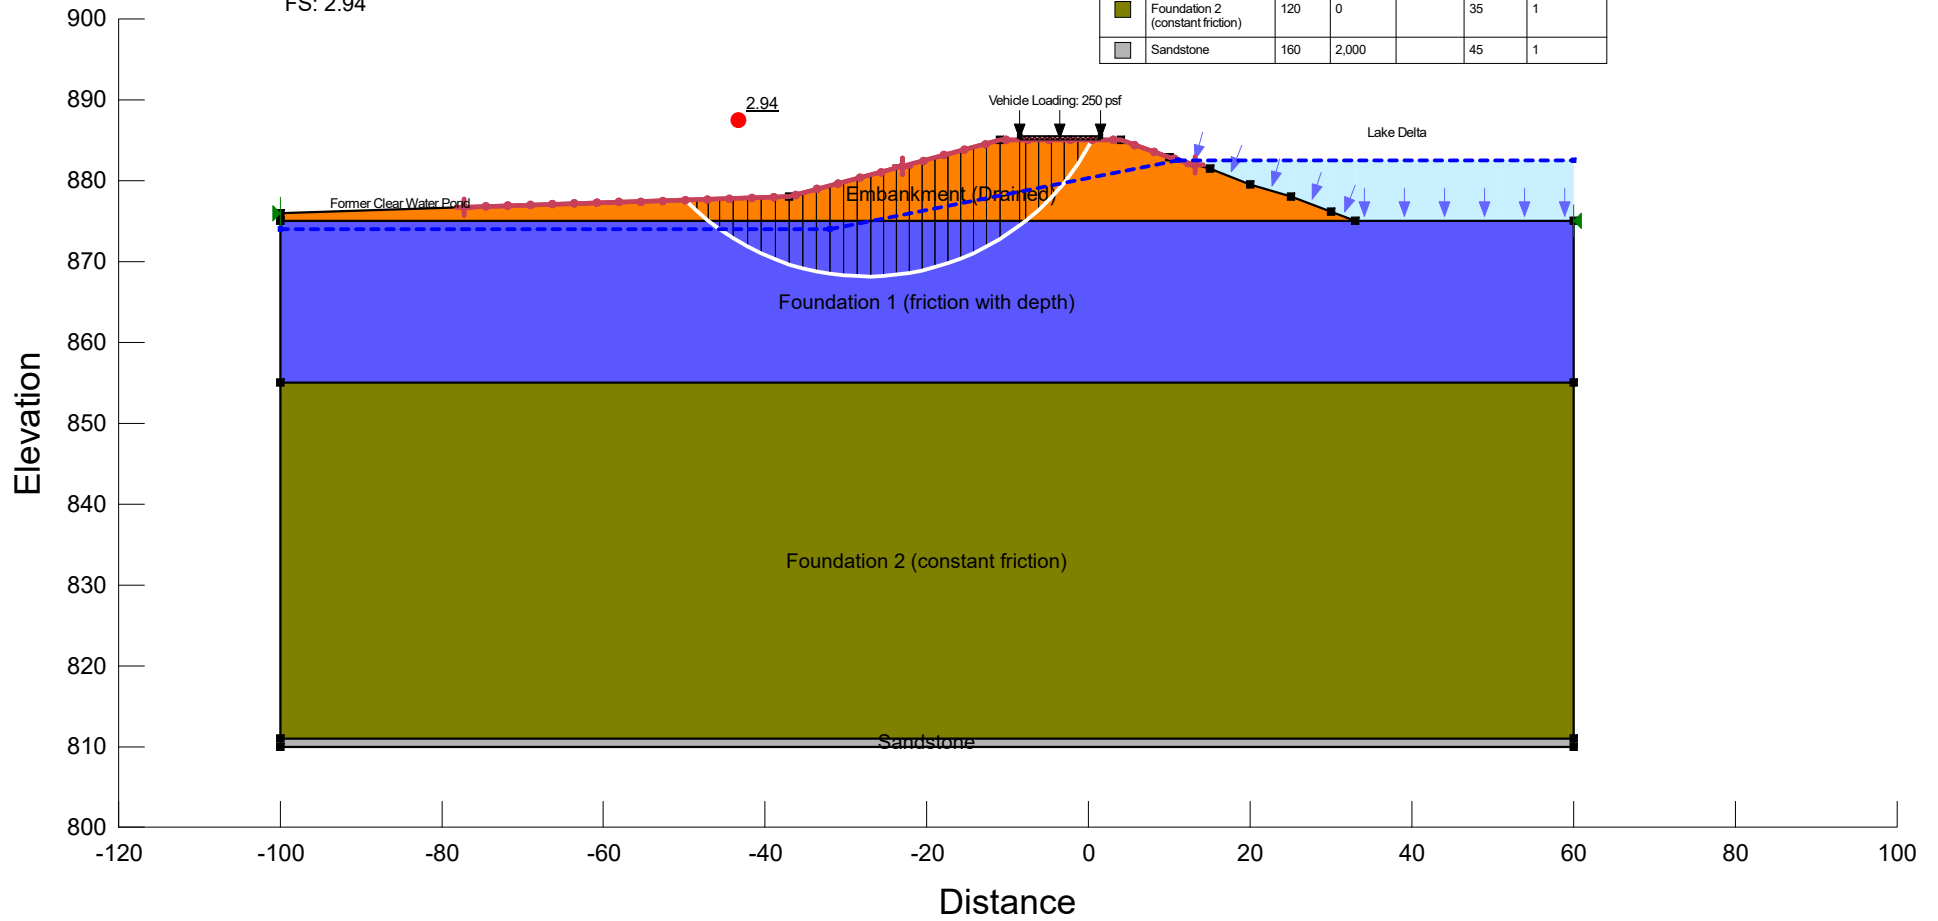
Name: Clear Water Pond - El. 882.5 feet
Description: Normal Pool, Drained Conditions
Method: Spencer
FS: 2.94

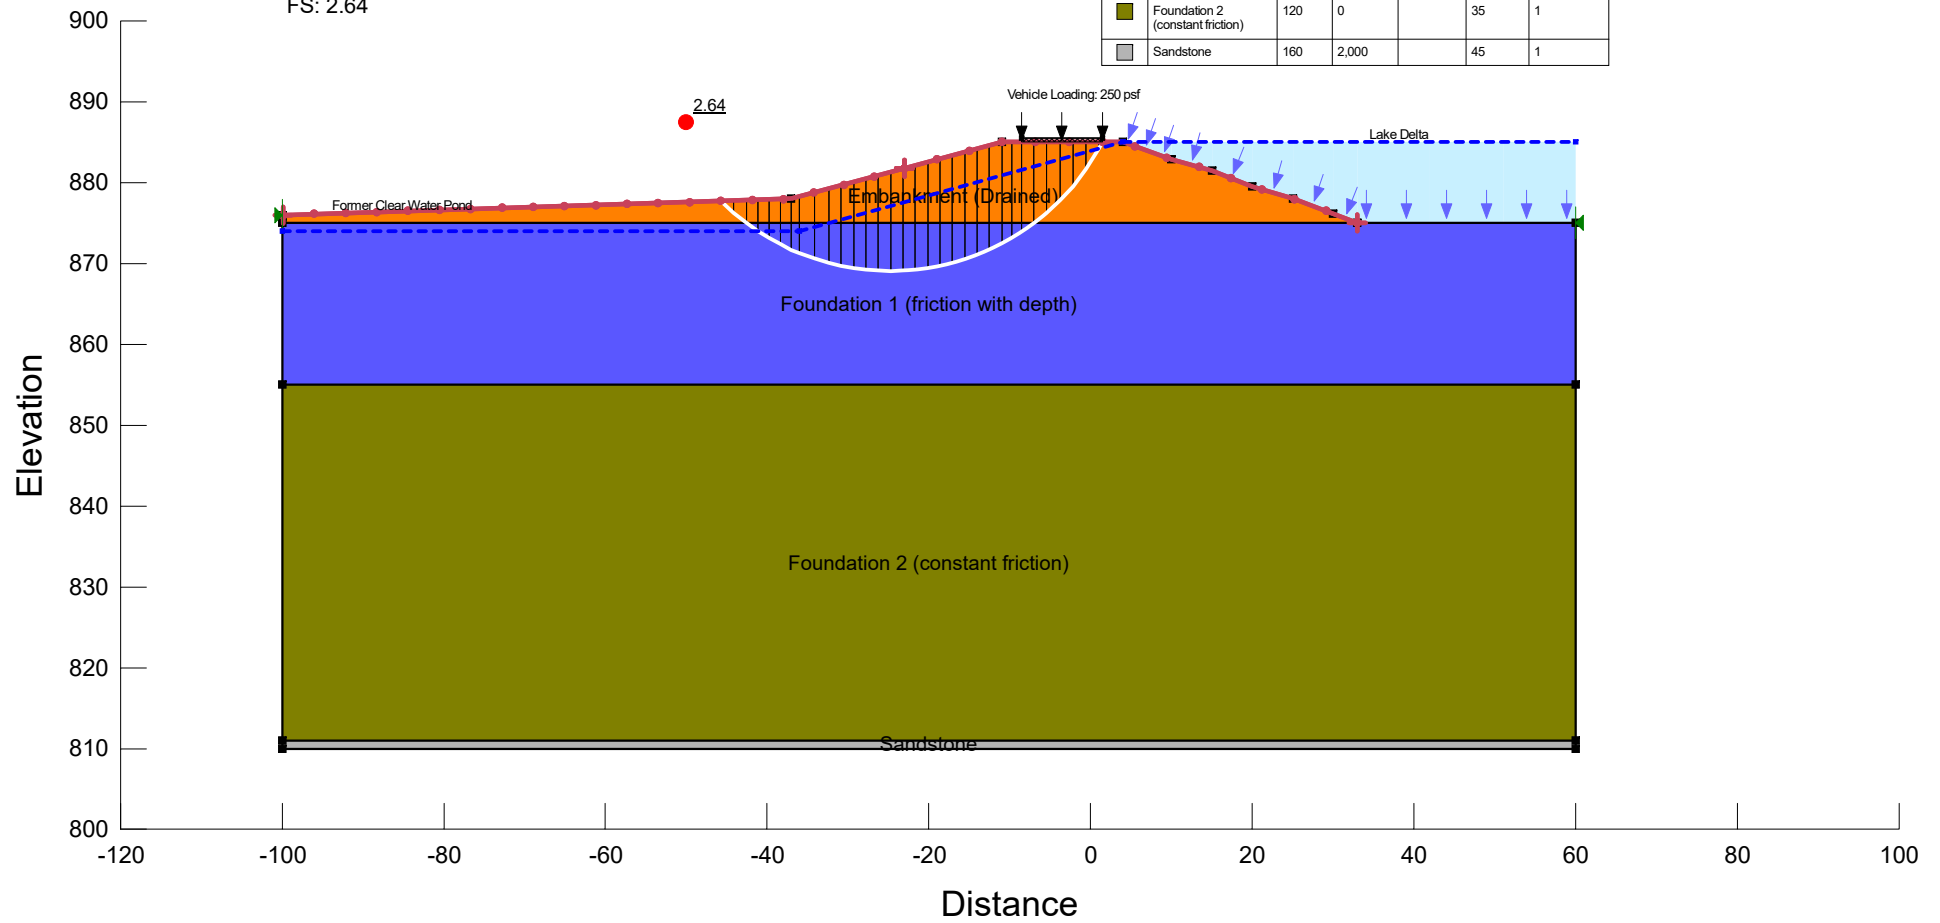
Name: Clear Water Pond - El. 885 feet
Description: Surcharge Pool, Drained Conditions
Method: Spencer
FS: 2.64

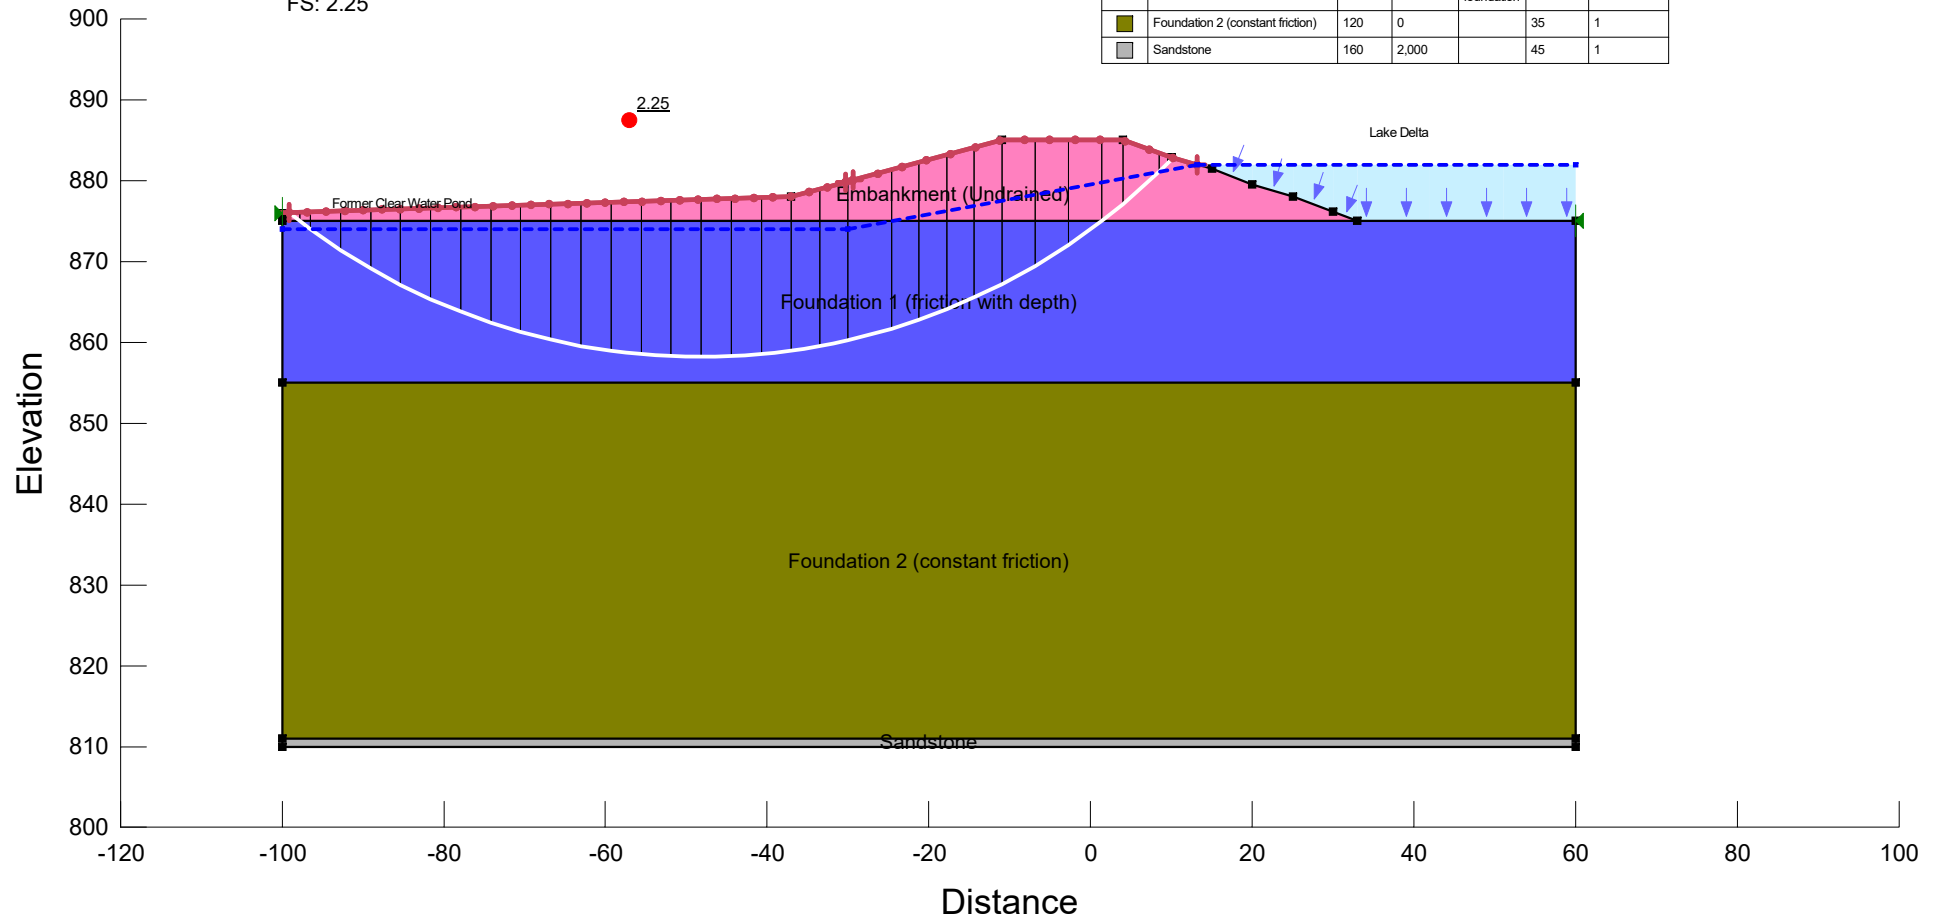
Name: Earthquake
Description: Normal Pool, Undrained Conditions
Method: Spencer
FS: 2.25
