# Annual Inspection Report - 2023

For Compliance with the EPA Coal  
Combustion Residuals (CCR) Rule  
40 CFR §257.83(b)

Erickson Power Station –  
Forebay, Retention Basin, and  
Clear Water Pond

February 24, 2023

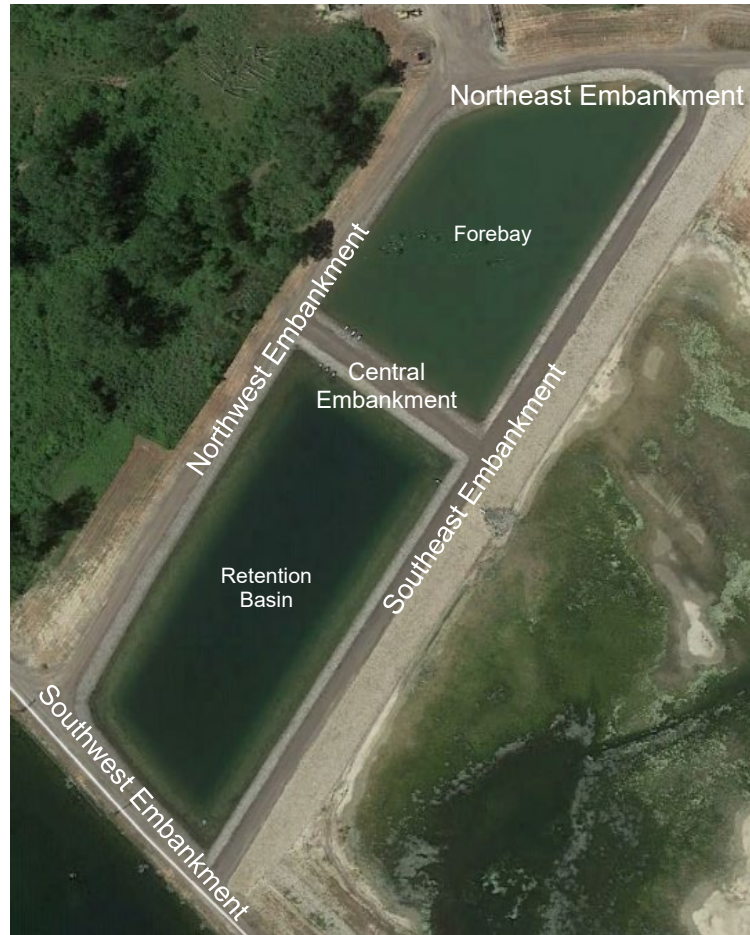
**Figure 4. Forebay and Retention Basin Embankment Terminology**

The Southeast Embankment separates the Forebay and Retention Basin to the northwest and the Former Impoundment, which is closed, to the southeast. The Southeast Embankment appeared to be in good condition and no evidence of movement, settlement, cracking, distress, erosion, seepage, animal burrows or other adverse conditions was observed in the crest and upstream and downstream slopes.

- The crest of the embankment consisted of a gravelly/soil surface which was in good condition.
- Rip-rap protects the interior and exterior slopes, which was in good condition.
- Vegetation has been maintained properly since the previous inspection.
- The vents installed as part of the liner system were visible, appeared to be in good condition, and were free of debris.

- Riprap protects the interior slope. The crest of the embankment consisted of a gravelly/soil surface. The crest and slopes appeared to be in good condition.
- The corner of the Northeast Embankment has experienced erosion from BWL personnel activities which exposed the liner in a small area of the interior embankment in late 2022. There is no concern of embankment stability at this location as the impoundments are currently being dewatered and decommissioned.
- Vegetation has been maintained properly since the previous inspection.

- Riprap protects the interior slope. The crest of the embankment consisted of a gravelly/soil surface. The crest and slopes appeared to be in good condition.
- The vents installed as part of the liner system were visible, appeared to be in good condition, however, some of the vent outlets were close to the ground level due to movement of surficial soil. These vents will soon be removed as part of the impoundment closure project in 2023.
- Vegetation has been maintained properly since the previous inspection.

- Riprap protects the interior slope and vegetation covers the exterior slope (adjacent to Lake Delta). The crest of the embankment consisted of a gravelly/soil surface. The crest and slopes appeared to be in good condition.

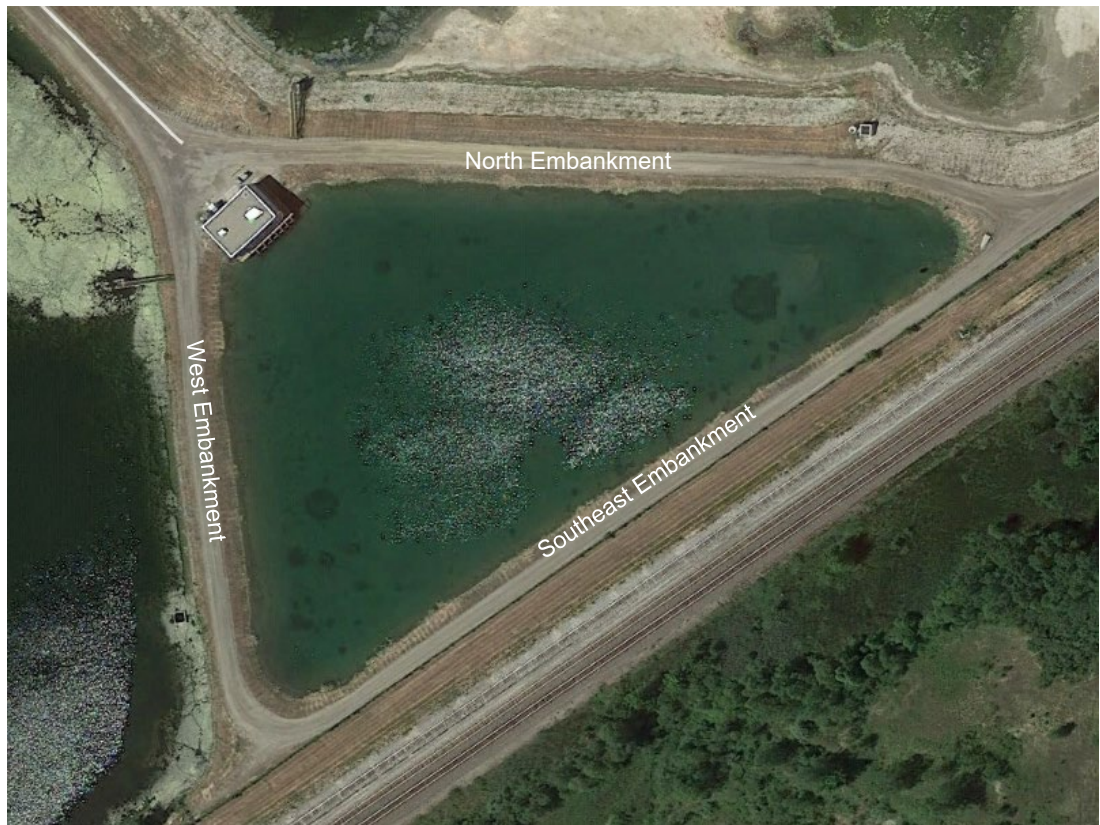
Figure 6. Clear Water Pond Embankment Terminology

The Southeast Embankment separates the Clear Water Pond to the northwest and the swale and railroad to the southeast. The Southeast Embankment appeared to be in good condition and no evidence of movement, settlement, cracking, distress, erosion, seepage, animal burrows or other adverse conditions was observed in the crest and upstream and downstream slopes.

- The crest of the embankment consisted of a gravelly/soil surface. Minor rutting of the crest was observed.
- Riprap protects the interior and exterior slopes, which was in good condition.
- The small diameter trees that were present in the last annual inspection had been removed and the fence on the crest had been replaced.

- Vegetation appears to have been maintained properly on both sides of the embankment.
- There was evidence of sloughing on the interior slope of the North Embankment which was observed in previous inspections.
- Riprap protects the exterior slope (adjacent to the Former Impoundment) in several areas. The rip-rap extends to the crest of the exterior slope on the eastern portion of the North Embankment, whereas the rip-rap extends to a vegetated bench on the western portion of the North Embankment.
- The crest of the embankment consisted of a gravelly/soil surface. No evidence of movement, settlement, cracking, or other distress was observed in the crest other than minor rutting.

- Vegetation appears to have been maintained properly on both sides of the embankment.
- The crest of the embankment consisted of a gravelly/soil. No evidence of movement, settlement, cracking, or other distress was observed in the crest.
