Structural Stability and Safety Factor Assessment

For Compliance with the EPA Coal
Combustion Residuals (CCR) Rule
40 CFR §257.73(d)
40 CFR §257.73(e)

Former Erickson Power Station –
Former Forebay, Former Retention Basin, and
Former Clear Water Pond

August 12, 2025

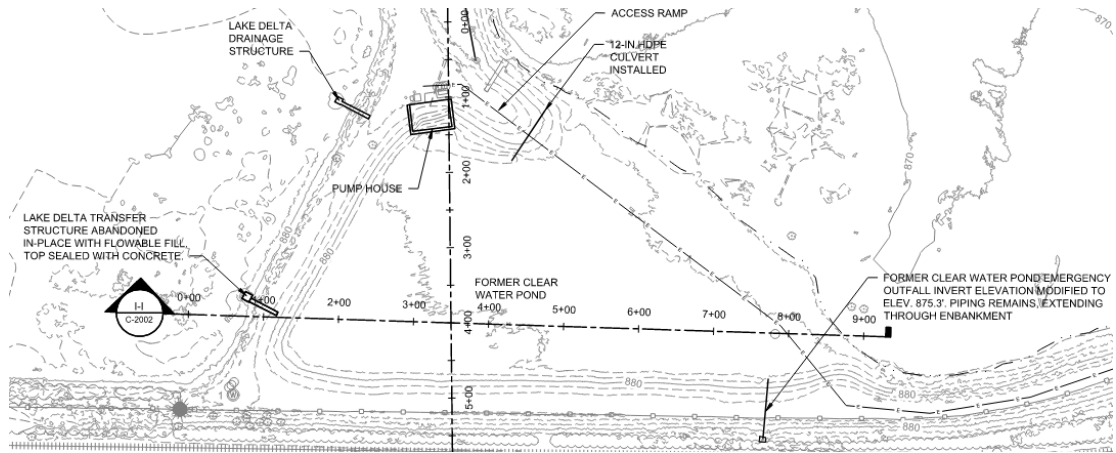
Figure 3. Location of Former Clear Water Pond Hydraulic Structures

The Former Forebay and Former Retention Basin no longer have embankments as these former impoundments have been filled. The Former Clear Water Pond has three hydraulic structures that extend through embankments:

- Lake Delta Drainage Structure
- Lake Delta Transfer Structure
- Emergency Overflow Structure

Hydraulic structures no longer pass through the Former Forebay or Former Retention Basin embankments. Details of each hydraulic structure are discussed in Section 1.2. Each hydraulic structure observed during the 2025 inspection (Ref. [9]) appeared to maintain structural integrity. The portions of the hydraulic structures that were underground or submerged were not inspected, however, there were no indications of settlement or distress of the embankment at the locations of the structures. It should be noted that the interior of the pipes and submerged pipes were not observed, and LBWL reported that no dewatered or remotely operated vehicle (ROV) internal inspections have been conducted.

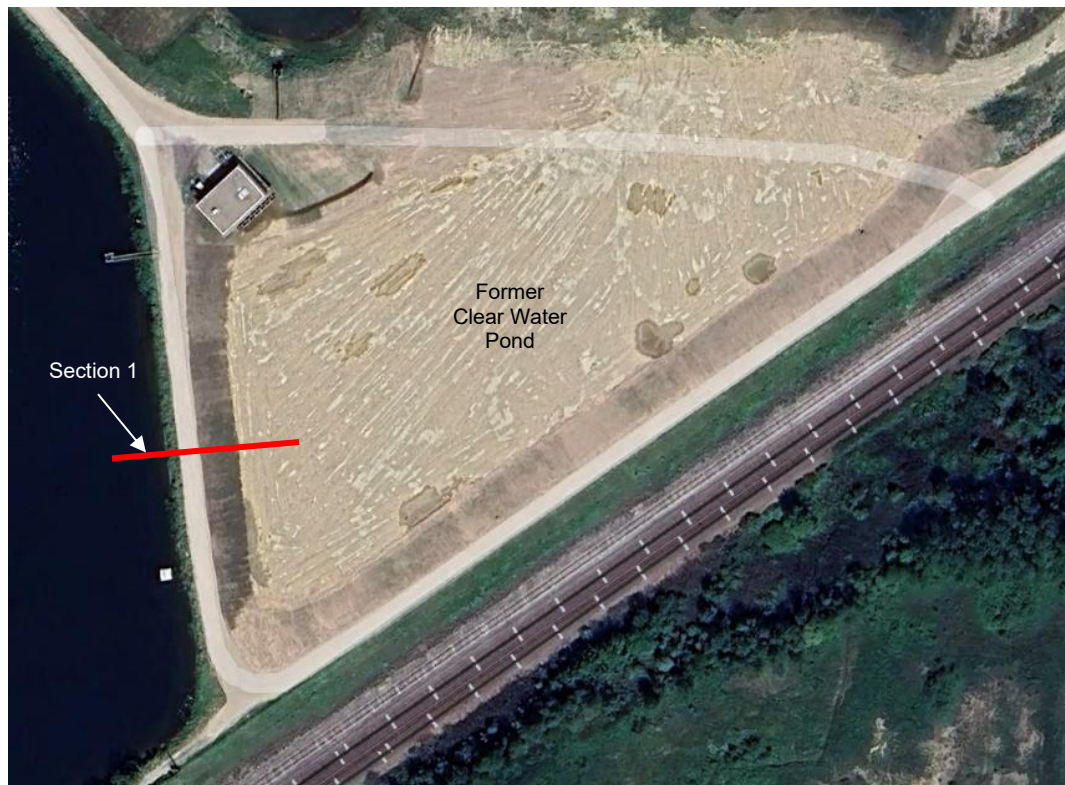
Figure 5. Location of Section 1

- Section 1, located at the western embankment of the Former Clear Water Pond, is adjacent to Lake Delta. Section 1 was selected due to the geometry of the slope and the differential head acting on the section. Due to the geometry that is present for this portion of the Former Clear Water Pond embankment, it was deemed more critical than the other portions of the embankment alignment.

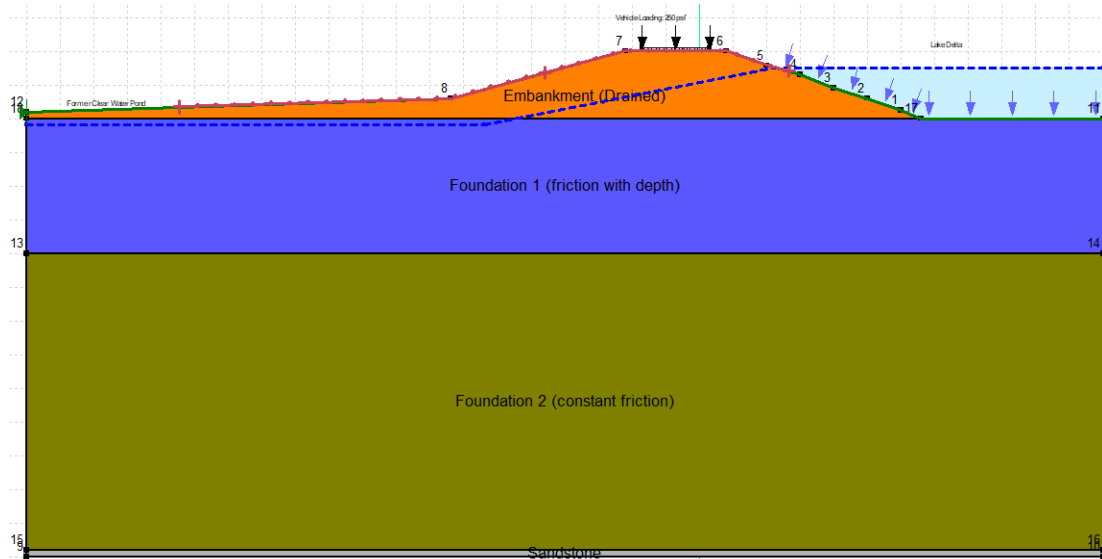
Figure 6. Section 1 Cross Section

The embankment stratigraphy is shown in Figure 6 and the material properties used for the slope stability analysis are presented in Table 3-2. The estimated material engineering properties were based on correlations with Standard Penetration Testing (SPT) performed in 1969 and HDR's experience with similar conditions. The boring logs are provided in Attachment 1. HDR used undrained and drained shear strengths related to effective stresses, as recommended by the USACE.
